Refurbishment Survey

44 Oxford Street
Woodstock
Oxfordshire
OX20 1TT

Amity

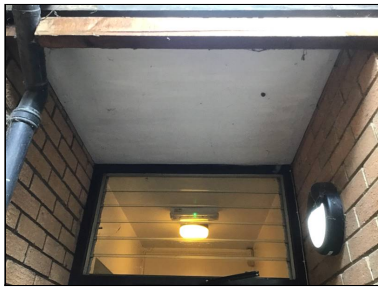
Survey Date:	Lead Surveyor	Survey Type	Floor	Analysis
	12 May 2025	Matthew Monro	Refurbishment Survey	External	No Asbestos Detected (0)
	Building	Room	Item	Quantity	
	Woodstock Social Club	External areas E01	Board Porch ceiling	1m²	
	Sample No (S,SP,P,As)	Product Type	Surface Treatment	Condition	Accessibility
	AB007404 (S)		Surface Sealed (1)	Good Condition (0)	Usually inaccessible or unlikely to be disturbed
		Material Risk Score			
	N/A				
Recommended action	No further action required				
Surveyor comments	Non asbestos board to side entrance porch ceiling

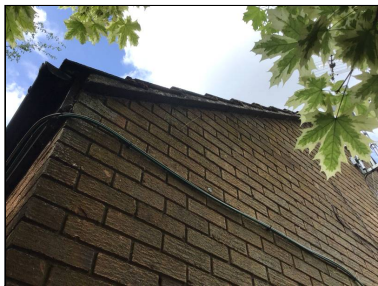
Survey Date:	Lead Surveyor	Survey Type	Floor	Analysis
	12 May 2025	Matthew Monro	Refurbishment Survey	External	Chrysotile (1)
	Building	Room	Item	Quantity	
	Woodstock Social Club	External areas E01	Undercloaking Roof	Throughout	
	Sample No (S,SP,P,As)	Product Type	Surface Treatment	Condition	Accessibility
	AB007405 (S)	Asbestos Cement (1)	Surface Sealed (1)	Low Damage (1)	Usually inaccessible or unlikely to be disturbed
		Material Risk Score			
	4				
Recommended action	F - Remove prior to works				
Surveyor comments	Undercloaking to gables of roof

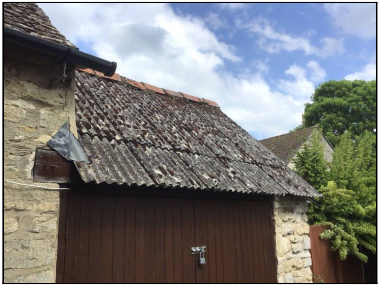
Survey Date:	Lead Surveyor	Survey Type	Floor	Analysis
	12 May 2025	Matthew Monro	Refurbishment Survey	External	Chrysotile (1)
	Building	Room	Item	Quantity	
	Woodstock Social Club	External areas E01	Corrugated cement sheets Roof	6m ²	
	Sample No (S,SP,P,As)	Product Type	Surface Treatment	Condition	Accessibility
	AB007406 (S)	Asbestos Cement (1)	Surface Sealed (1)	Low Damage (1)	Occasionally likely to be disturbed
	Material Risk Score				
Recommended action		F - Remove prior to works			
Surveyor comments		Cement sheets to rear store

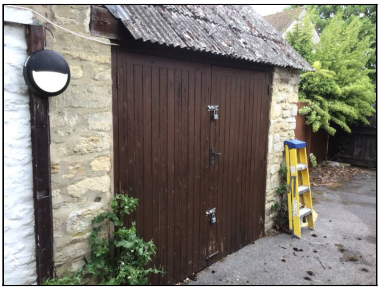
Survey Date:	Lead Surveyor	Survey Type	Floor	Analysis
	12 May 2025	Matthew Monro	Refurbishment Survey	Ground Floor	N/A
	Building	Room	Item	Quantity	
	Woodstock Social Club	Outside store G01	Inaccessible	N/A	
	Sample No (S,SP,P,As)	Product Type	Surface Treatment	Condition	Accessibility
	Visual (P)	N/A	N/A	N/A	N/A
	Material Risk Score				
Recommended action		Inspection Required			
Surveyor comments		No keys at time of survey

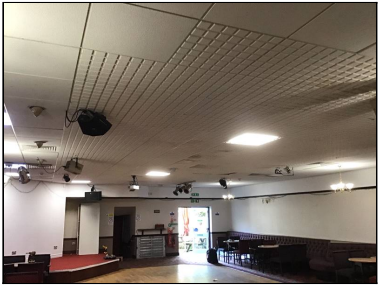
Survey Date:	Lead Surveyor	Survey Type	Floor	Analysis
	12 May 2025	Matthew Monro	Refurbishment Survey	Ground Floor	No Asbestos Detected (0)
	Building	Room	Item	Quantity	
	Woodstock Social Club	Charles Brooks hall G06	Plaster tile Ceiling	Throughout	
	Sample No (S,SP,P,As)	Product Type	Surface Treatment	Condition	Accessibility
	AB007397 (S)		Surface Sealed (1)	Good Condition (0)	Usually inaccessible or unlikely to be disturbed
	Material Risk Score				
Recommended action		No further action required			
Surveyor comments		Suspended plaster ceiling tiles

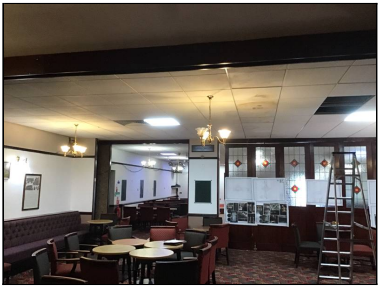
Survey Date:	Lead Surveyor	Survey Type	Floor	Analysis
	12 May 2025	Matthew Monro	Refurbishment Survey	Ground Floor	No Asbestos Detected (0)
	Building	Room	Item	Quantity	
	Woodstock Social Club	Seating area 1 G07	Plaster tile Ceiling	Throughout	
	Sample No (S,SP,P,As)	Product Type	Surface Treatment	Condition	Accessibility
	As AB007397 (SP)		Surface Sealed (1)	Good Condition (0)	Usually inaccessible or unlikely to be disturbed
	Material Risk Score				
Recommended action		No further action required			
Surveyor comments		Suspended plaster ceiling tiles

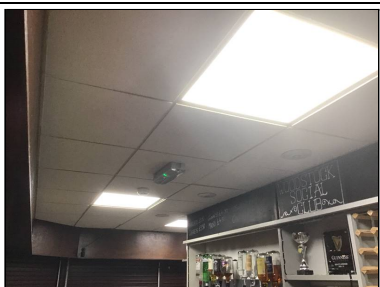
Survey Date:	Lead Surveyor	Survey Type	Floor	Analysis
	12 May 2025	Matthew Monro	Refurbishment Survey	Ground Floor	No Asbestos Detected (0)
	Building	Room	Item	Quantity	
	Woodstock Social Club	Bar G08	Plaster tiles Ceiling	Throughout	
	Sample No (S,SP,P,As)	Product Type	Surface Treatment	Condition	Accessibility
	As AB007397 (SP)		Surface Sealed (1)	Good Condition (0)	Usually inaccessible or unlikely to be disturbed
	Material Risk Score				
N/A					
Recommended action	No further action required				
Surveyor comments	Suspended plaster ceiling tiles

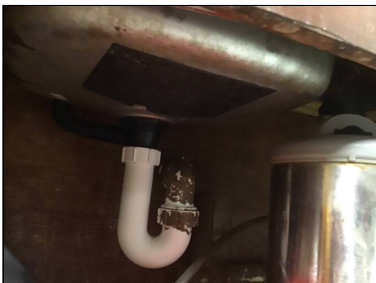
Survey Date:	Lead Surveyor	Survey Type	Floor	Analysis
	12 May 2025	Matthew Monro	Refurbishment Survey	Ground Floor	No Asbestos Detected (0)
	Building	Room	Item	Quantity	
	Woodstock Social Club	Bar G08	Acoustic pad Sink	2no.	
	Sample No (S,SP,P,As)	Product Type	Surface Treatment	Condition	Accessibility
	AB007398 (S)		Completely Sealed (0)	Good Condition (0)	Usually inaccessible or unlikely to be disturbed
	Material Risk Score				
N/A					
Recommended action	No further action required				
Surveyor comments	Acoustic pads to underside of sink

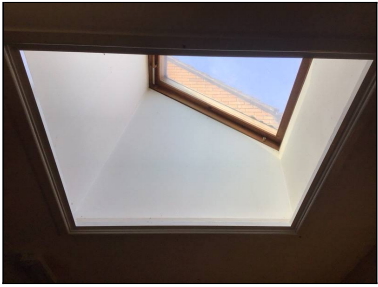
Survey Date:	Lead Surveyor	Survey Type	Floor	Analysis
	12 May 2025	Matthew Monro	Refurbishment Survey	Ground Floor	No Asbestos Detected (0)
	Building	Room	Item	Quantity	
	Woodstock Social Club	Seating area 2 G11	Board Skylight	4m ²	
	Sample No (S,SP,P,As)	Product Type	Surface Treatment	Condition	Accessibility
	AB007399 (S)		Surface Sealed (1)	Good Condition (0)	Usually inaccessible or unlikely to be disturbed
	Material Risk Score				
Recommended action		No further action required			
Surveyor comments		Non asbestos board to skylight upstand

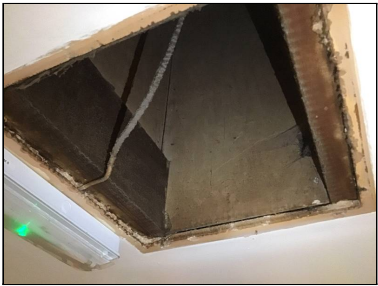
Survey Date:	Lead Surveyor	Survey Type	Floor	Analysis
	12 May 2025	Matthew Monro	Refurbishment Survey	Ground Floor	Chrysotile + Amosite (2)
	Building	Room	Item	Quantity	
	Woodstock Social Club	Seating area 2 G11	Insulating board Ceiling	4m ²	
	Sample No (S,SP,P,As)	Product Type	Surface Treatment	Condition	Accessibility
	AB007403 (S)	Asbestos Insulating Board (2)	Surface Sealed (1)	Low Damage (1)	Usually inaccessible or unlikely to be disturbed
	Material Risk Score				
Recommended action		G - Remove by a licensed contractor			
Surveyor comments		Board lining extractor vent in ceiling

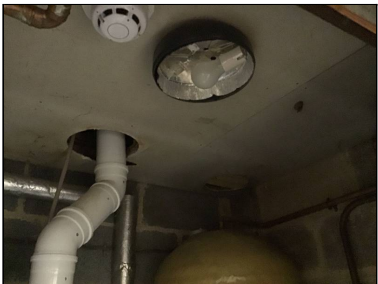
Survey Date:	Lead Surveyor	Survey Type	Floor	Analysis
	12 May 2025	Matthew Monro	Refurbishment Survey	Ground Floor	No Asbestos Detected (0)
	Building	Room	Item	Quantity	
	Woodstock Social Club	Boiler cupboard G13	Board Ceiling	2m ²	
	Sample No (S,SP,P,As)	Product Type	Surface Treatment	Condition	Accessibility
	AB007400 (S)		Unsealed (2)	Low Damage (1)	Occasionally likely to be disturbed
	Material Risk Score				
Recommended action		No further action required			
Surveyor comments		Non asbestos board to ceiling

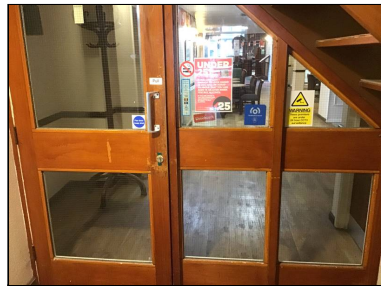
Survey Date:	Lead Surveyor	Survey Type	Floor	Analysis
	12 May 2025	Matthew Monro	Refurbishment Survey	Ground Floor	Amosite (2)
	Building	Room	Item	Quantity	
	Woodstock Social Club	Front stairwell G15	Beading Doors and windows	30lm	
	Sample No (S,SP,P,As)	Product Type	Surface Treatment	Condition	Accessibility
	AB007401 (S)	Asbestos Insulating Board (2)	Surface Sealed (1)	Good Condition (0)	Easily disturbed
	Material Risk Score				
	5				
Recommended action	G - Remove by a licensed contractor				
Surveyor comments	Glazing bead to timber doors and windows

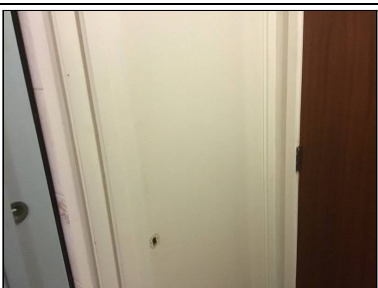
Survey Date:	Lead Surveyor	Survey Type	Floor	Analysis
	12 May 2025	Matthew Monro	Refurbishment Survey	Ground Floor	N/A
	Building	Room	Item	Quantity	
	Woodstock Social Club	Cleaners cupboard G17	Inaccessible	N/A	
	Sample No (S,SP,P,As)	Product Type	Surface Treatment	Condition	Accessibility
	Visual (P)	N/A	N/A	N/A	N/A
	Material Risk Score				
	N/A				
Recommended action	Inspection Required				
Surveyor comments	No keys at time of survey

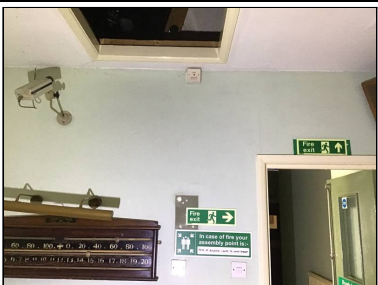
Survey Date:	Lead Surveyor	Survey Type	Floor	Analysis
	12 May 2025	Matthew Monro	Refurbishment Survey	1st Floor	Chrysotile + Amosite (2)
	Building	Room	Item	Quantity	
	Woodstock Social Club	Snooker room 102	Insulating board Boxing	4m²	
	Sample No (S,SP,P,As)	Product Type	Surface Treatment	Condition	Accessibility
	As AB007402 (SP)	Asbestos Insulating Board (2)	Surface Sealed (1)	Good Condition (0)	Usually inaccessible or unlikely to be disturbed
	Material Risk Score				
5					
Recommended action	G - Remove by a licensed contractor				
Surveyor comments	Insulation board to boxing behind plasterboard

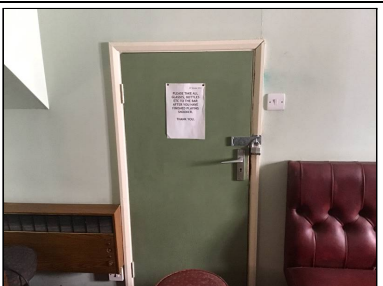
Survey Date:	Lead Surveyor	Survey Type	Floor	Analysis
	12 May 2025	Matthew Monro	Refurbishment Survey	1st Floor	N/A
	Building	Room	Item	Quantity	
	Woodstock Social Club	Snooker room store 103	Inaccessible	N/A	
	Sample No (S,SP,P,As)	Product Type	Surface Treatment	Condition	Accessibility
	Visual (P)	N/A	N/A	N/A	N/A
	Material Risk Score				
	N/A				
Recommended action	Inspection Required				
Surveyor comments	No keys at time of survey

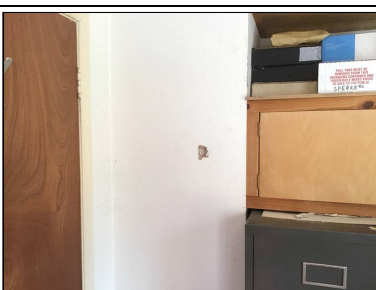
Survey Date:	Lead Surveyor	Survey Type	Floor	Analysis
	12 May 2025	Matthew Monro	Refurbishment Survey	1st Floor	Chrysotile + Amosite (2)
	Building	Room	Item	Quantity	
	Woodstock Social Club	Office 104	Insulating board Boxing	8m²	
	Sample No (S,SP,P,As)	Product Type	Surface Treatment	Condition	Accessibility
	As AB007402 (SP)	Asbestos Insulating Board (2)	Surface Sealed (1)	Good Condition (0)	Usually inaccessible or unlikely to be disturbed
	Material Risk Score				
	5				
Recommended action	G - Remove by a licensed contractor				
Surveyor comments	Insulation board to boxing in wall behind door

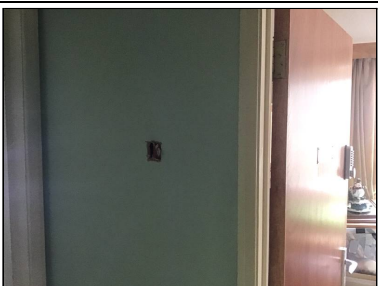
Survey Date:	Lead Surveyor	Survey Type	Floor	Analysis
	12 May 2025	Matthew Monro	Refurbishment Survey	1st Floor	Chrysotile + Amosite (2)
	Building	Room	Item	Quantity	
	Woodstock Social Club	Hallway 105	Insulating board Boxing	4m²	
	Sample No (S,SP,P,As)	Product Type	Surface Treatment	Condition	Accessibility
	As AB007402 (SP)	Asbestos Insulating Board (2)	Surface Sealed (1)	Good Condition (0)	Usually inaccessible or unlikely to be disturbed
	Material Risk Score				
	5				
Recommended action	G - Remove by a licensed contractor				
Surveyor comments	Insulation board to boxing behind plasterboard next to office door

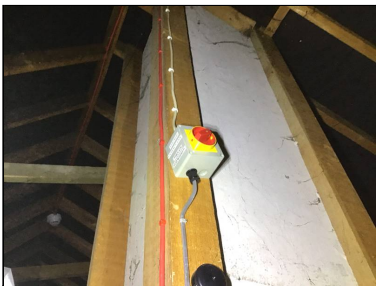
Survey Date:	Lead Surveyor	Survey Type	Floor	Analysis
	12 May 2025	Matthew Monro	Refurbishment Survey	Roof Void	Chrysotile + Amosite (2)
	Building	Room	Item	Quantity	
	Woodstock Social Club	First floor loft R03	Insulating board Boxing	6m²	
	Sample No (S,SP,P,As)	Product Type	Surface Treatment	Condition	Accessibility
	AB007402 (S)	Asbestos Insulating Board (2)	Unsealed (2)	Good Condition (0)	Usually inaccessible or unlikely to be disturbed
	Material Risk Score				
6					
Recommended action	G - Remove by a licensed contractor				
Surveyor comments	Insulation board to boxing in loft space
