Refurbishment Survey

44 Oxford Street
Woodstock
Oxfordshire
OX20 1TT

Amity

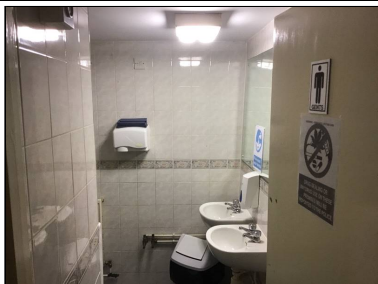
Survey Date:	Lead Surveyor	Survey Type	Floor	Analysis
	12 May 2025	Matthew Monro	Refurbishment Survey	Ground Floor	N/A
	Building	Room	Item	Quantity	
	Woodstock Social Club	Gents toilet G02	No suspect materials found	N/A	
	Sample No (S,SP,P,As)	Product Type	Surface Treatment	Condition	Accessibility
	Visual	N/A	N/A	N/A	N/A
	Material Risk Score				
	N/A				
Recommended action	No further action required				
Surveyor comments	N/A

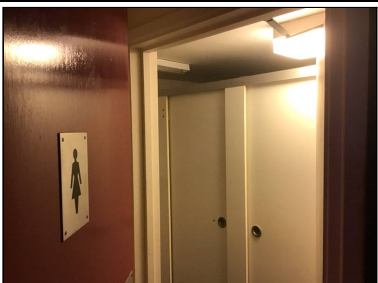
Survey Date:	Lead Surveyor	Survey Type	Floor	Analysis
	12 May 2025	Matthew Monro	Refurbishment Survey	Ground Floor	N/A
	Building	Room	Item	Quantity	
	Woodstock Social Club	Ladies toilet G03	No suspect materials found	N/A	
	Sample No (S,SP,P,As)	Product Type	Surface Treatment	Condition	Accessibility
	Visual	N/A	N/A	N/A	N/A
	Material Risk Score				
	N/A				
Recommended action	No further action required				
Surveyor comments	N/A

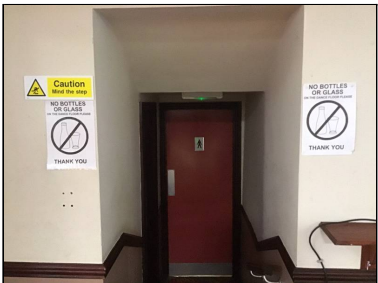
Survey Date:	Lead Surveyor	Survey Type	Floor	Analysis
	12 May 2025	Matthew Monro	Refurbishment Survey	Ground Floor	N/A
	Building	Room	Item	Quantity	
	Woodstock Social Club	Toilet lobby G04	No suspect materials found	N/A	
	Sample No (S,SP,P,As)	Product Type	Surface Treatment	Condition	Accessibility
	Visual	N/A	N/A	N/A	N/A
	Material Risk Score				
Recommended action		No further action required			
Surveyor comments		N/A

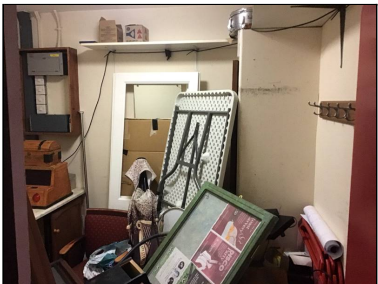
Survey Date:	Lead Surveyor	Survey Type	Floor	Analysis
	12 May 2025	Matthew Monro	Refurbishment Survey	Ground Floor	N/A
	Building	Room	Item	Quantity	
	Woodstock Social Club	Stage store G05	No suspect materials found	N/A	
	Sample No (S,SP,P,As)	Product Type	Surface Treatment	Condition	Accessibility
	Visual	N/A	N/A	N/A	N/A
	Material Risk Score				
Recommended action		No further action required			
Surveyor comments		N/A

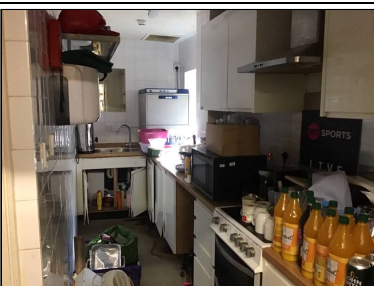
Survey Date:	Lead Surveyor	Survey Type	Floor	Analysis
	12 May 2025	Matthew Monro	Refurbishment Survey	Ground Floor	N/A
	Building	Room	Item	Quantity	
	Woodstock Social Club	Kitchen G09	No suspect materials found	N/A	
	Sample No (S,SP,P,As)	Product Type	Surface Treatment	Condition	Accessibility
	Visual	N/A	N/A	N/A	N/A
	Material Risk Score				
	N/A				
Recommended action	No further action required				
Surveyor comments	N/A

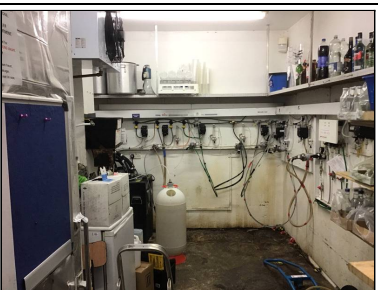
Survey Date:	Lead Surveyor	Survey Type	Floor	Analysis
	12 May 2025	Matthew Monro	Refurbishment Survey	Ground Floor	N/A
	Building	Room	Item	Quantity	
	Woodstock Social Club	Cellar G10	No suspect materials found	N/A	
	Sample No (S,SP,P,As)	Product Type	Surface Treatment	Condition	Accessibility
	Visual	N/A	N/A	N/A	N/A
	Material Risk Score				
	N/A				
Recommended action	No further action required				
Surveyor comments	N/A

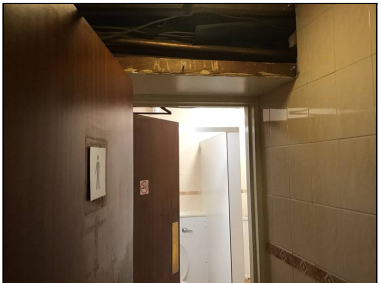
Survey Date:	Lead Surveyor	Survey Type	Floor	Analysis
	12 May 2025	Matthew Monro	Refurbishment Survey	Ground Floor	N/A
	Building	Room	Item	Quantity	
	Woodstock Social Club	Gents toilet G14	No suspect materials found	N/A	
	Sample No (S,SP,P,As)	Product Type	Surface Treatment	Condition	Accessibility
	Visual	N/A	N/A	N/A	N/A
	Material Risk Score				
Recommended action		No further action required			
Surveyor comments		N/A

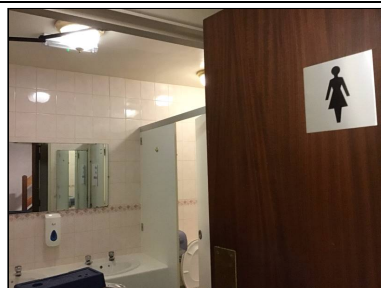
Survey Date:	Lead Surveyor	Survey Type	Floor	Analysis
	12 May 2025	Matthew Monro	Refurbishment Survey	Ground Floor	N/A
	Building	Room	Item	Quantity	
	Woodstock Social Club	Ladies toilet G16	No suspect materials found	N/A	
	Sample No (S,SP,P,As)	Product Type	Surface Treatment	Condition	Accessibility
	Visual	N/A	N/A	N/A	N/A
	Material Risk Score				
	N/A				
Recommended action	No further action required				
Surveyor comments	N/A

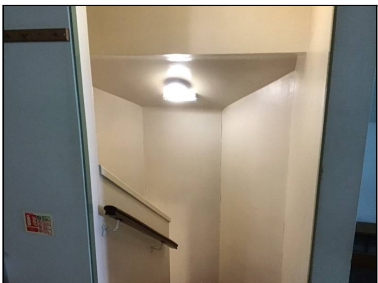
Survey Date:	Lead Surveyor	Survey Type	Floor	Analysis
	12 May 2025	Matthew Monro	Refurbishment Survey	1st Floor	N/A
	Building	Room	Item	Quantity	
	Woodstock Social Club	Rear stairwell 101	No suspect materials found	N/A	
	Sample No (S,SP,P,As)	Product Type	Surface Treatment	Condition	Accessibility
	Visual	N/A	N/A	N/A	N/A
	Material Risk Score				
	N/A				
Recommended action	No further action required				
Surveyor comments	N/A

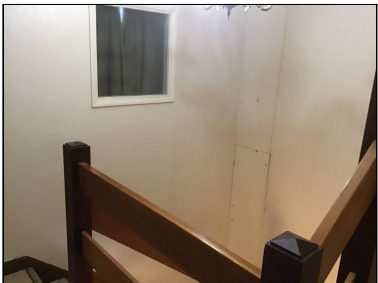
Survey Date:	Lead Surveyor	Survey Type	Floor	Analysis
	12 May 2025	Matthew Monro	Refurbishment Survey	1st Floor	N/A
	Building	Room	Item	Quantity	
	Woodstock Social Club	Front stairwell 106	No suspect materials found	N/A	
	Sample No (S,SP,P,As)	Product Type	Surface Treatment	Condition	Accessibility
	Visual	N/A	N/A	N/A	N/A
	Material Risk Score				
Recommended action		No further action required			
Surveyor comments		N/A

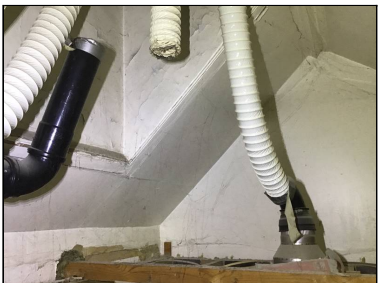
Survey Date:	Lead Surveyor	Survey Type	Floor	Analysis
	12 May 2025	Matthew Monro	Refurbishment Survey	Roof Void	N/A
	Building	Room	Item	Quantity	
	Woodstock Social Club	Ladies toilet loft R01	No suspect materials found	N/A	
	Sample No (S,SP,P,As)	Product Type	Surface Treatment	Condition	Accessibility
	Visual	N/A	N/A	N/A	N/A
	Material Risk Score				
Recommended action		No further action required			
Surveyor comments		N/A

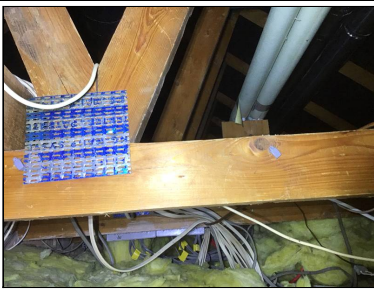
Survey Date:	Lead Surveyor	Survey Type	Floor	Analysis
	12 May 2025	Matthew Monro	Refurbishment Survey	Roof Void	N/A
	Building	Room	Item	Quantity	
	Woodstock Social Club	Cellar loft R02	No suspect materials found	N/A	
	Sample No (S,SP,P,As)	Product Type	Surface Treatment	Condition	Accessibility
	Visual	N/A	N/A	N/A	N/A
	Material Risk Score				
N/A					
Recommended action	No further action required				
Surveyor comments	N/A
